Technical Report CERC-96-8
September 1996

Periodic Inspection of Burns Harbor North Breakwater, Indiana

Report 1 Base Conditions

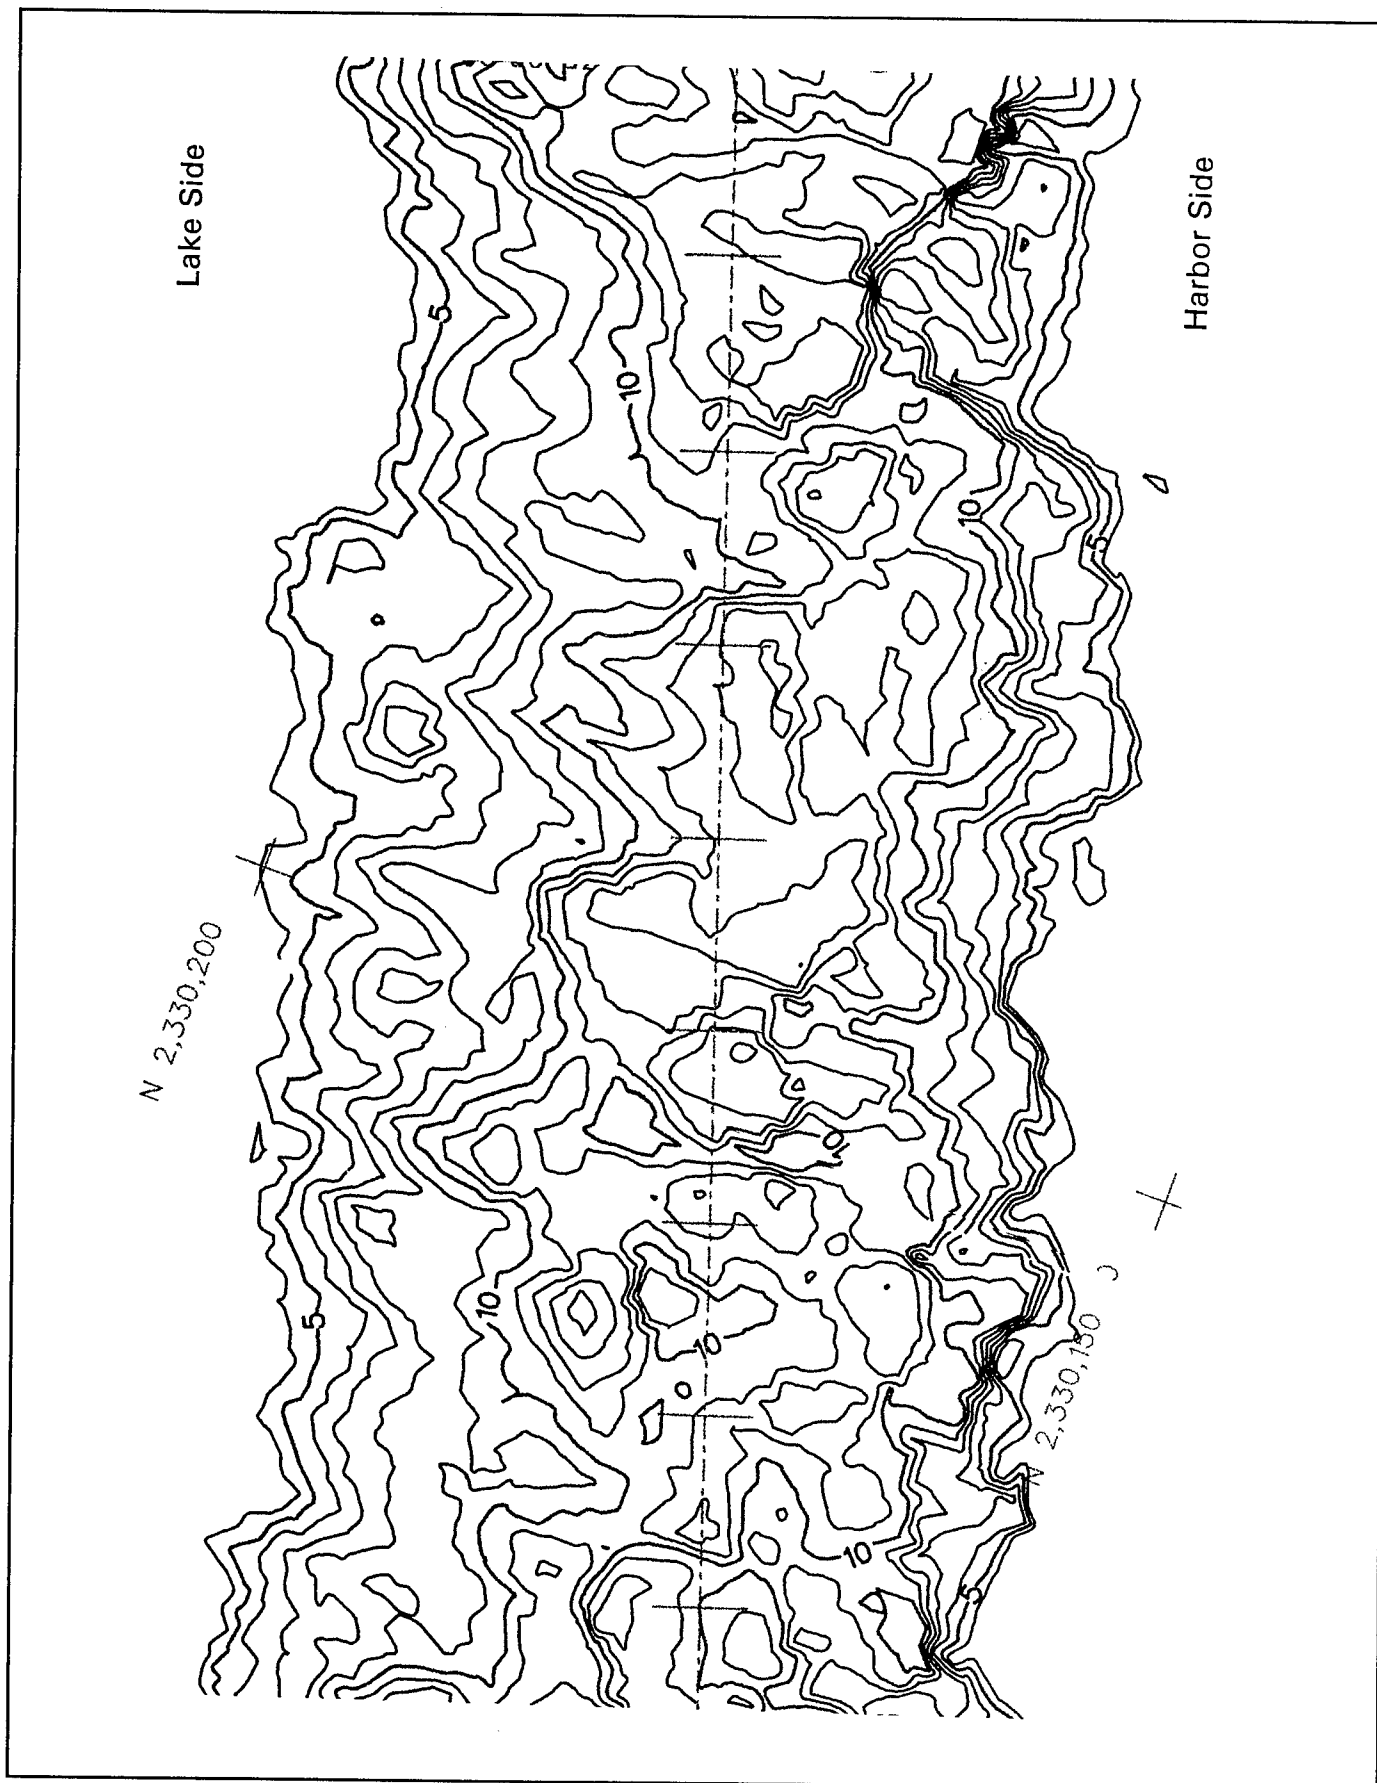
Figure A42. Topography of Burns Harbor North Breakwater, sta 35+00-35+85

This appendix presents contour maps of the Burns Harbor North Breakwater. Topography was developed using the digital terrain model (DTM) as stated in the main text of this report. The breakwater topography is shown on a 0.3-m (1.0-ft) contour interval. Elevations shown are in feet referred to low water datum (lwd). To convert them to meters, multiply by 0.3048. Station numbering on the contour maps is from east to west (right to left). The scale of the maps is 25.4 mm = 3.05 m (1 in = 10 ft).

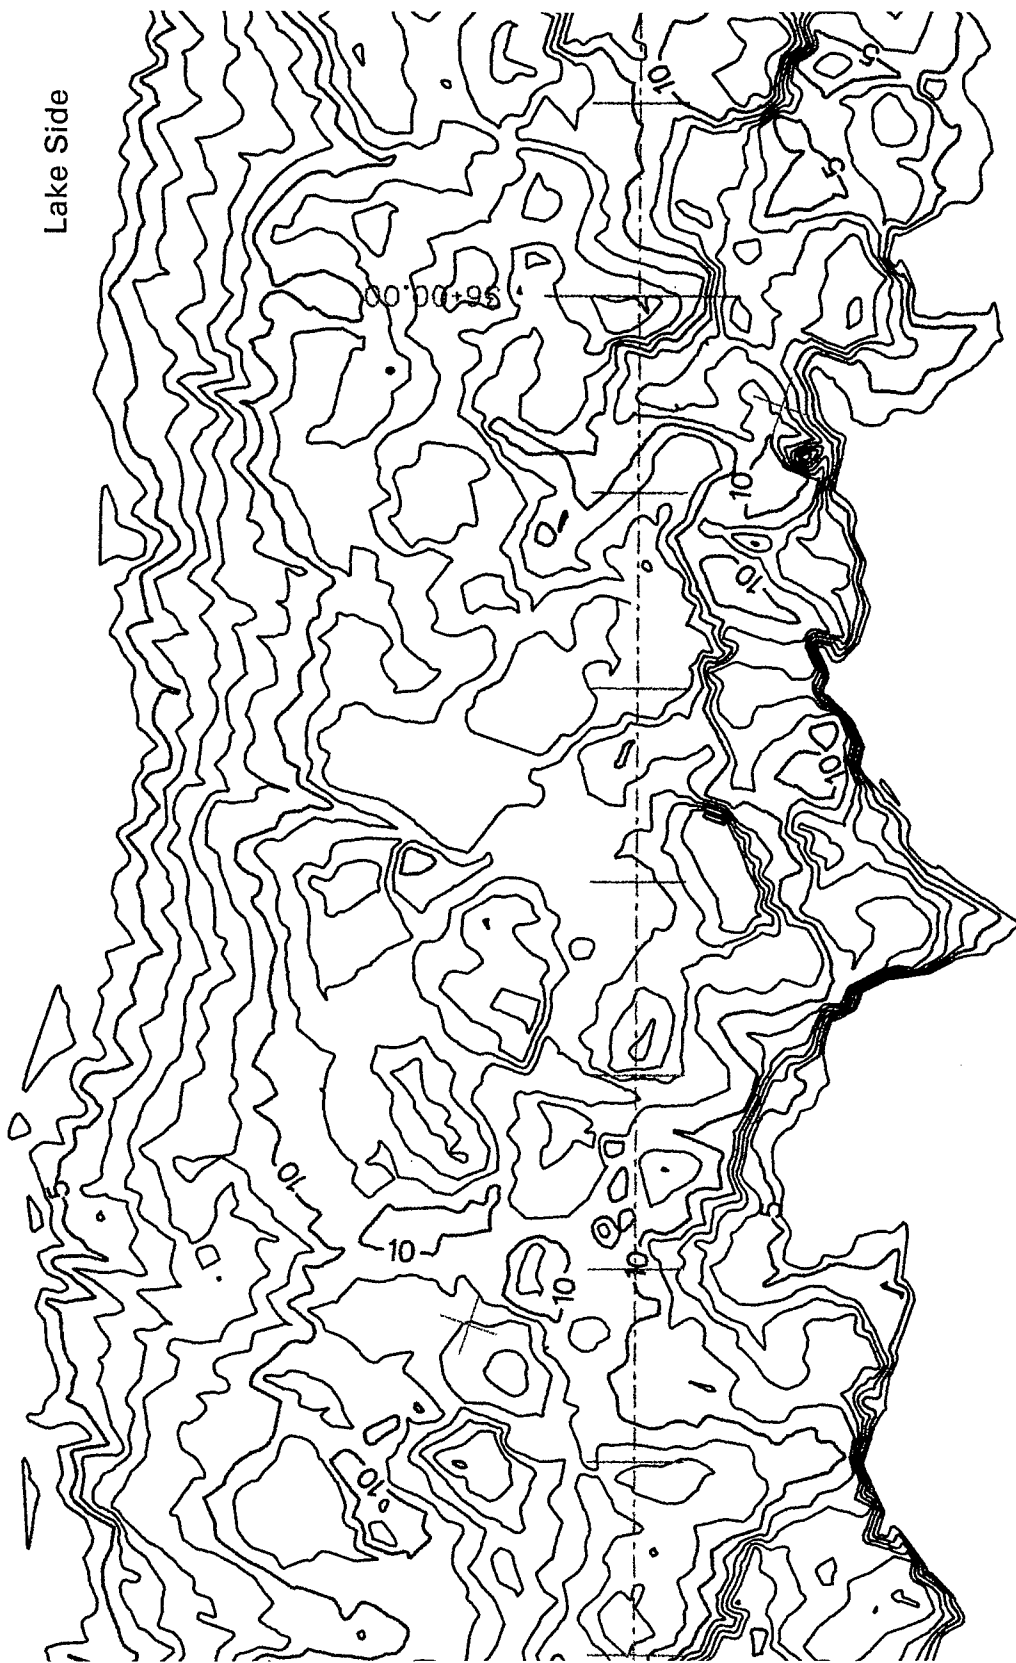
Figure A43. Topography of Burns Harbor North Breakwater, sta 35+85-36+70

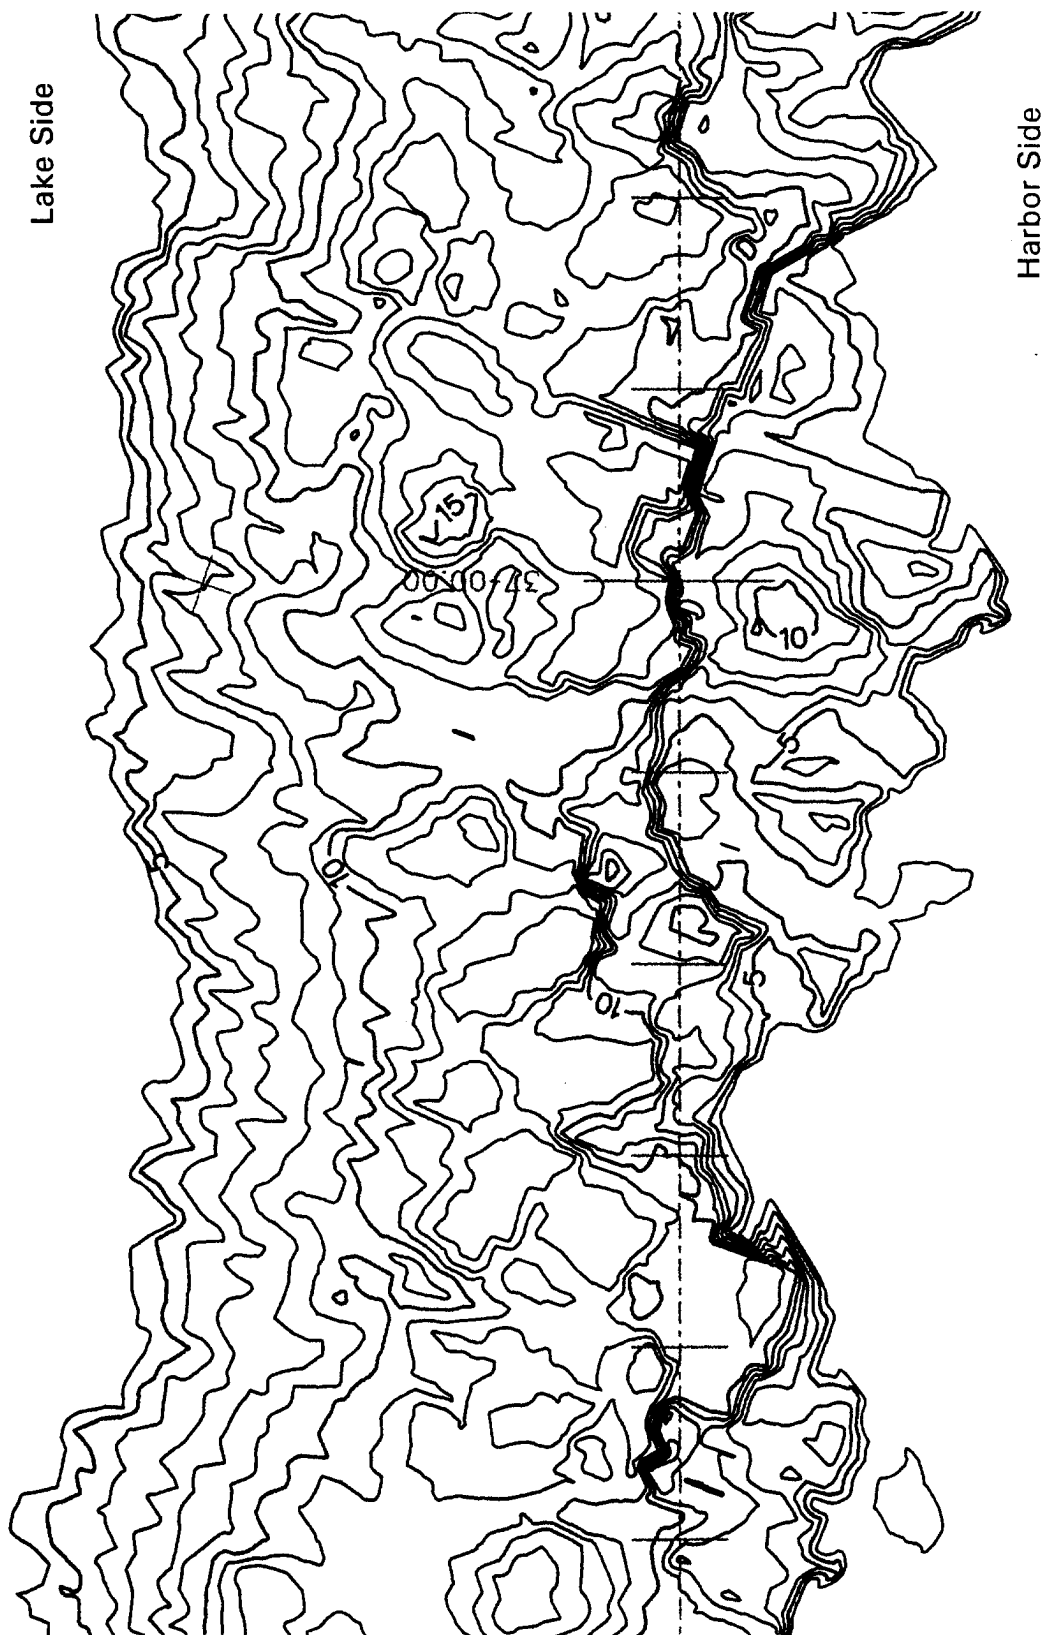
Figure A44. Topography of Burns Harbor North Breakwater, sta 36+70-37+55

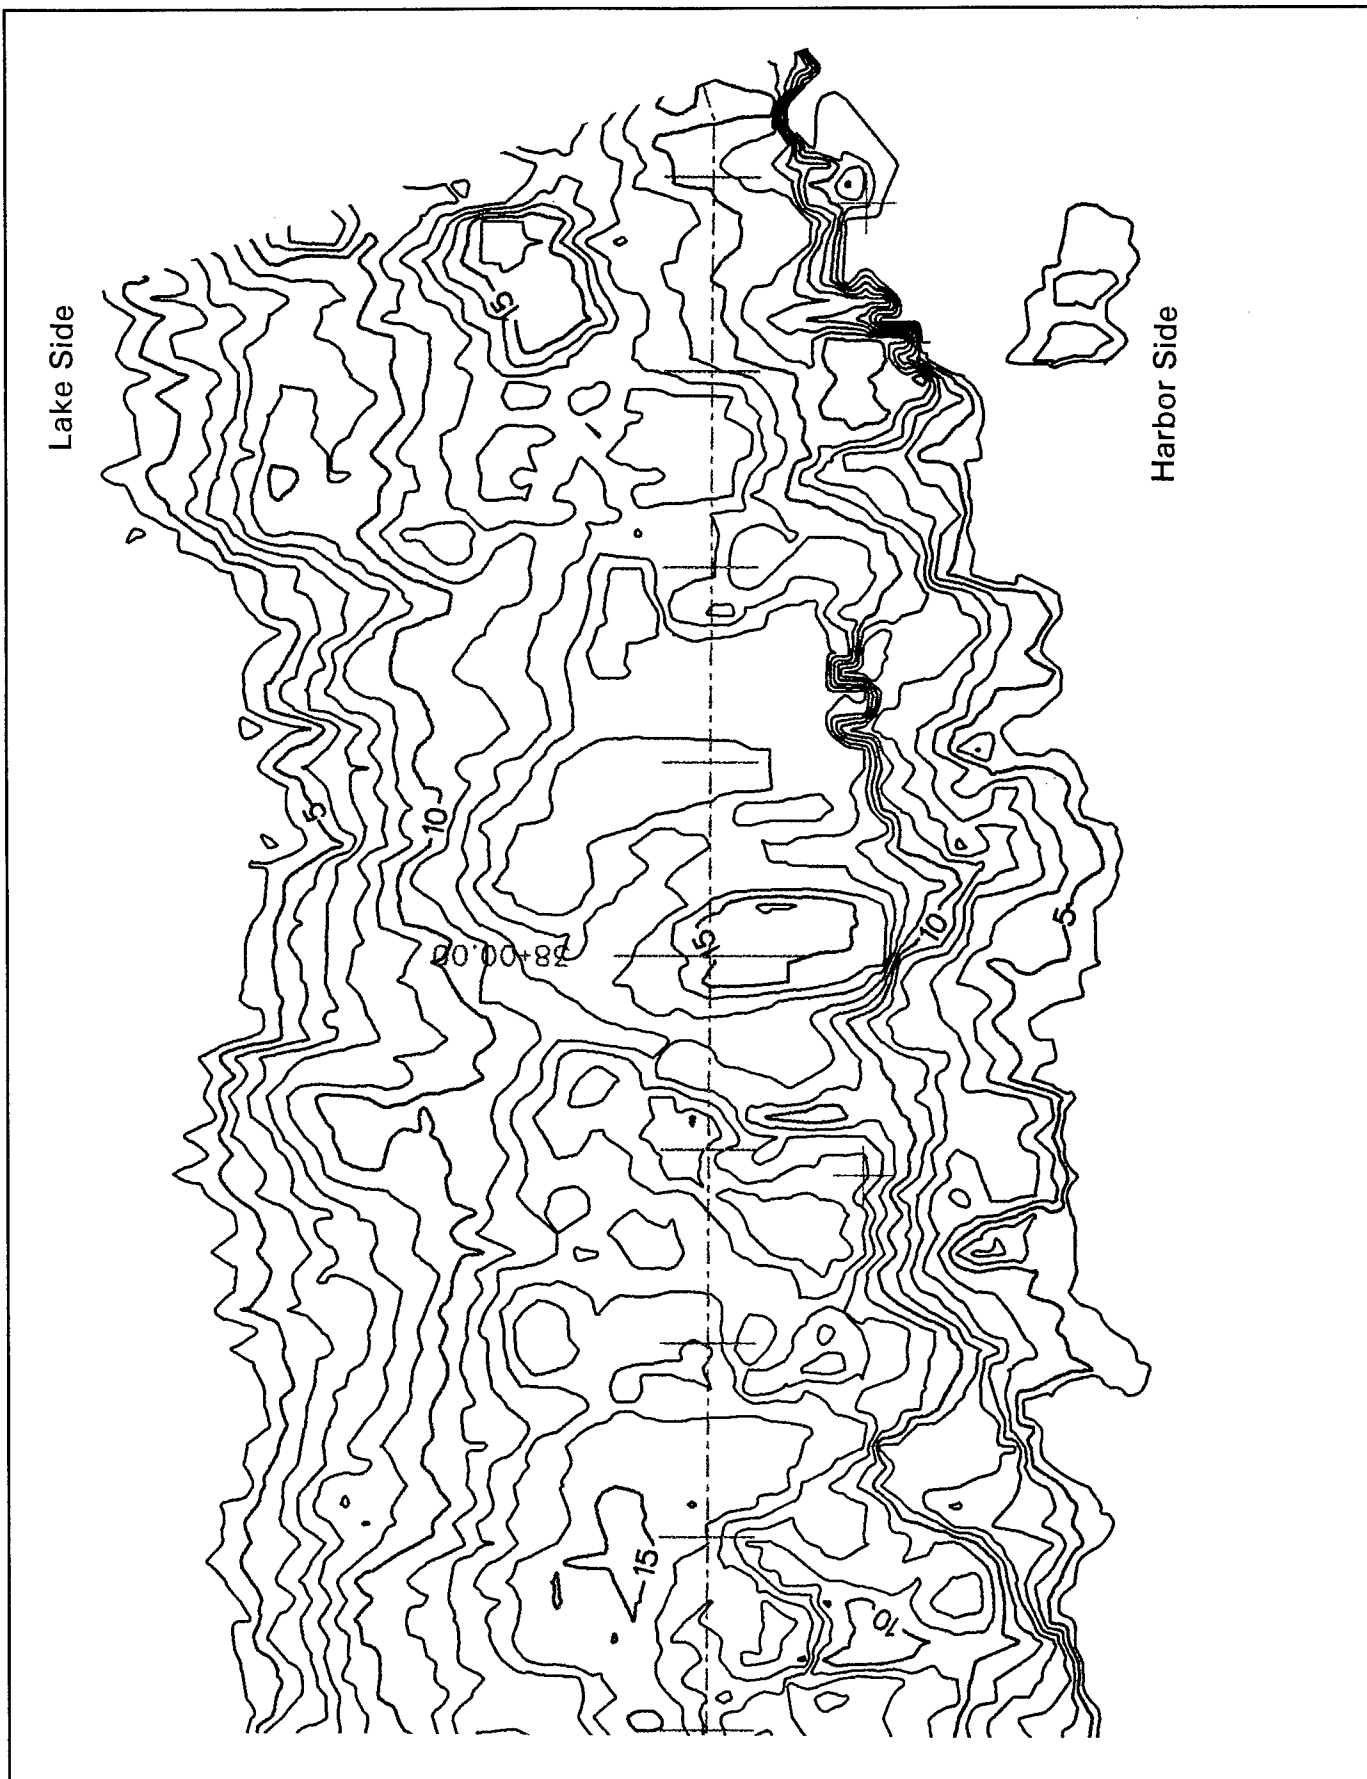
Figure A45. Topography of Burns Harbor North Breakwater, sta 37+55-38+40

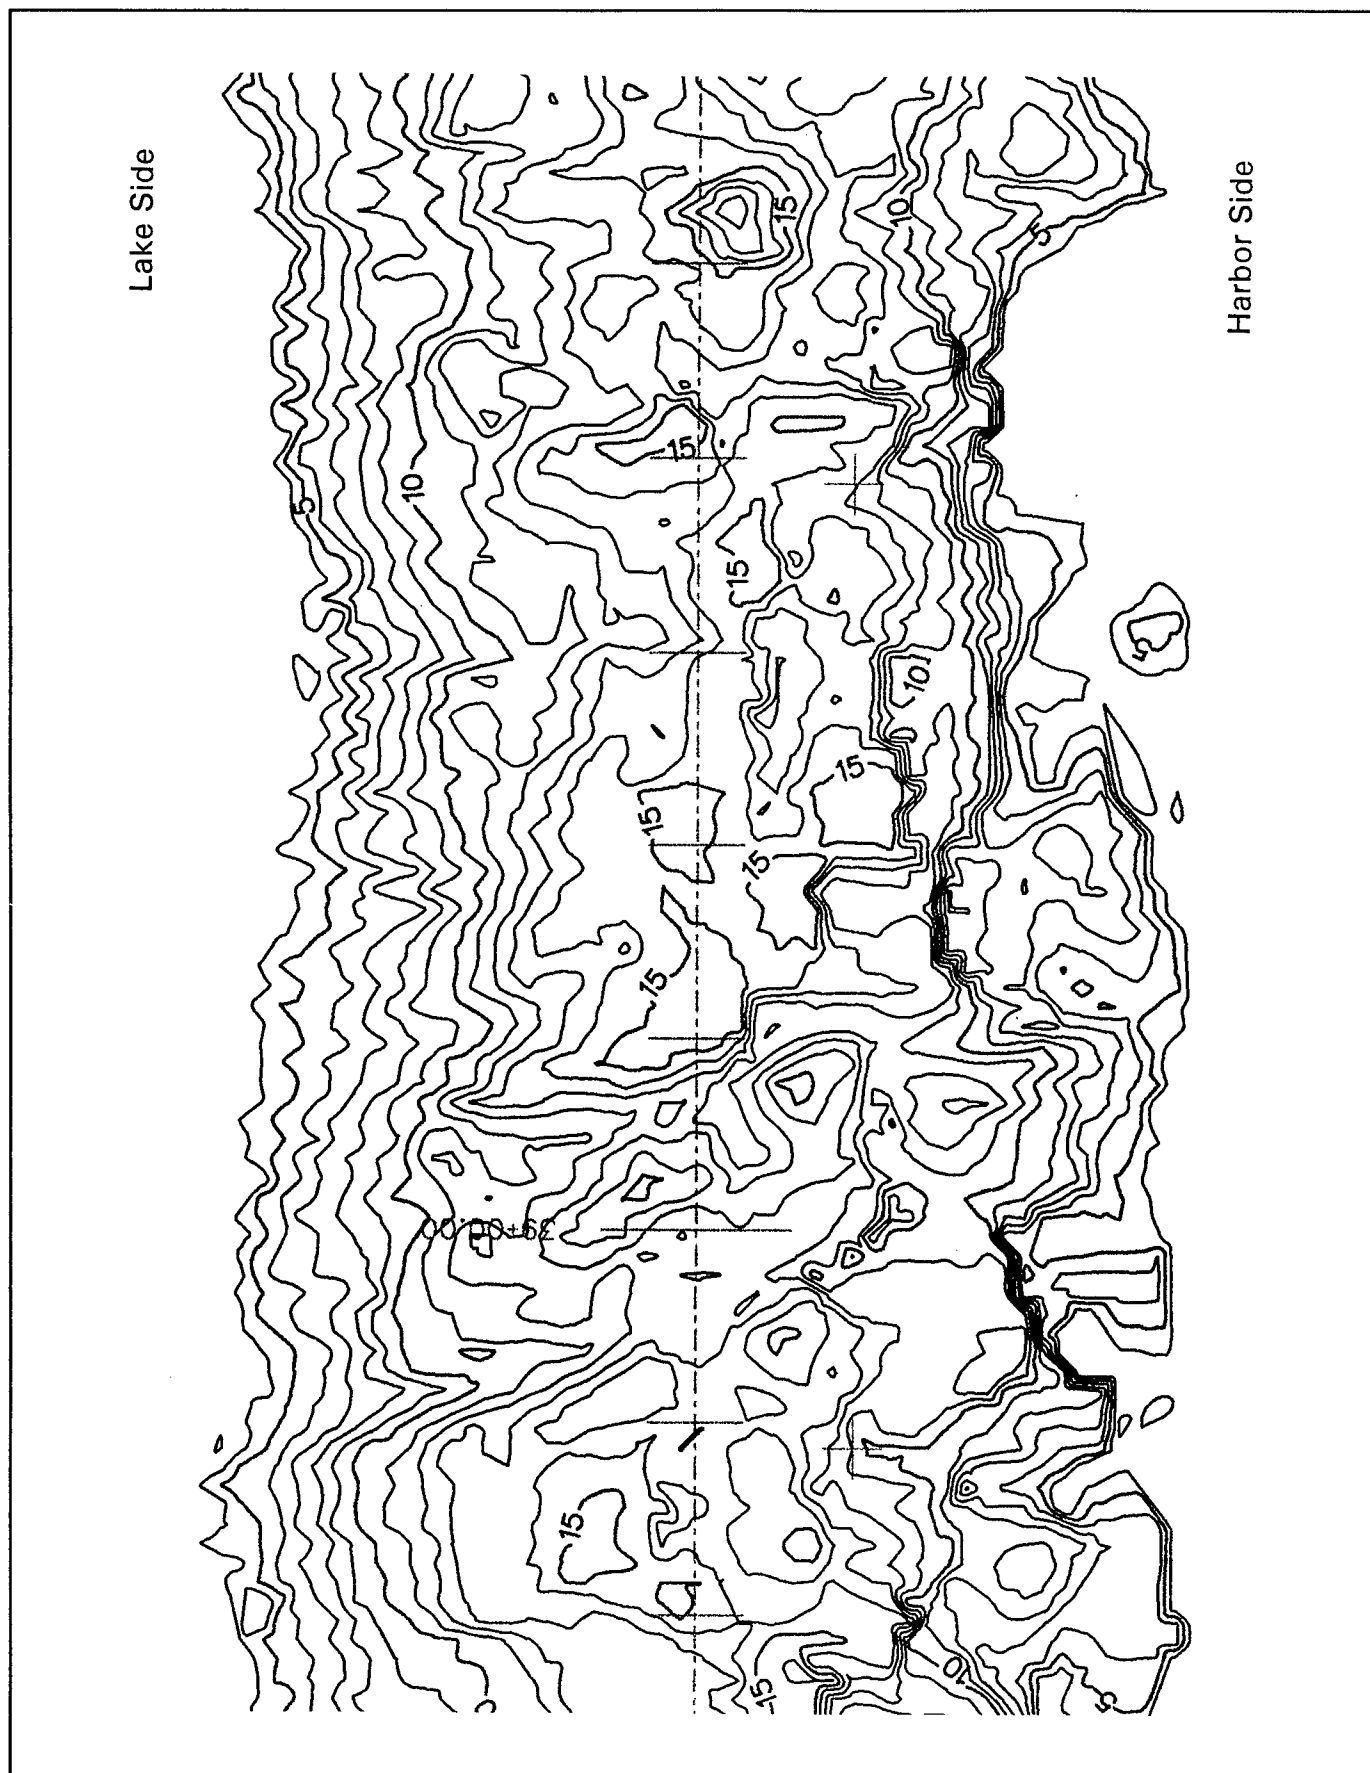
Figure A46. Topography of Burns Harbor North Breakwater, sta 38+40-39+25

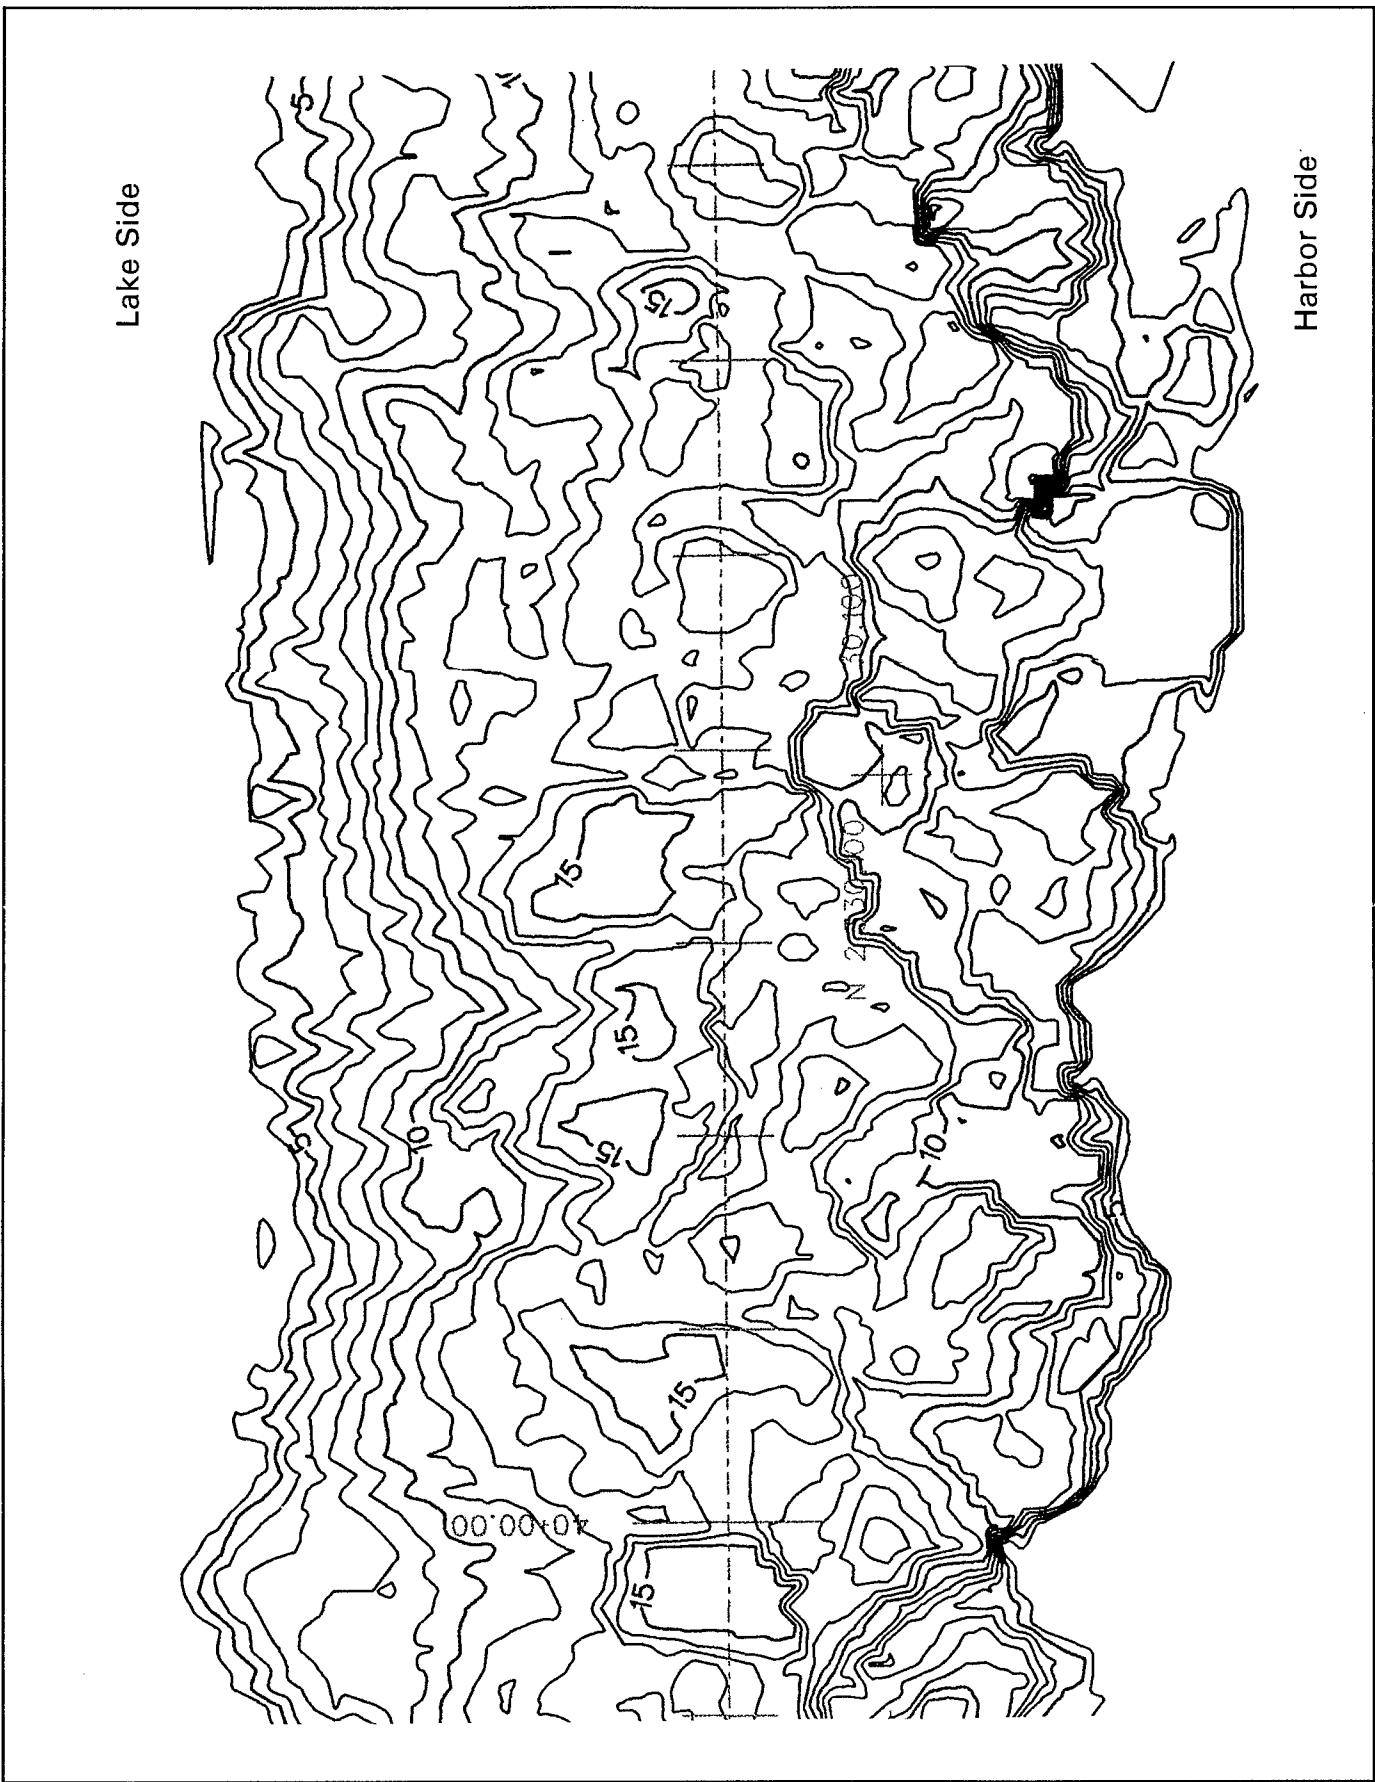
Figure A47. Topography of Burns Harbor North Breakwater, sta 39+25-40+10

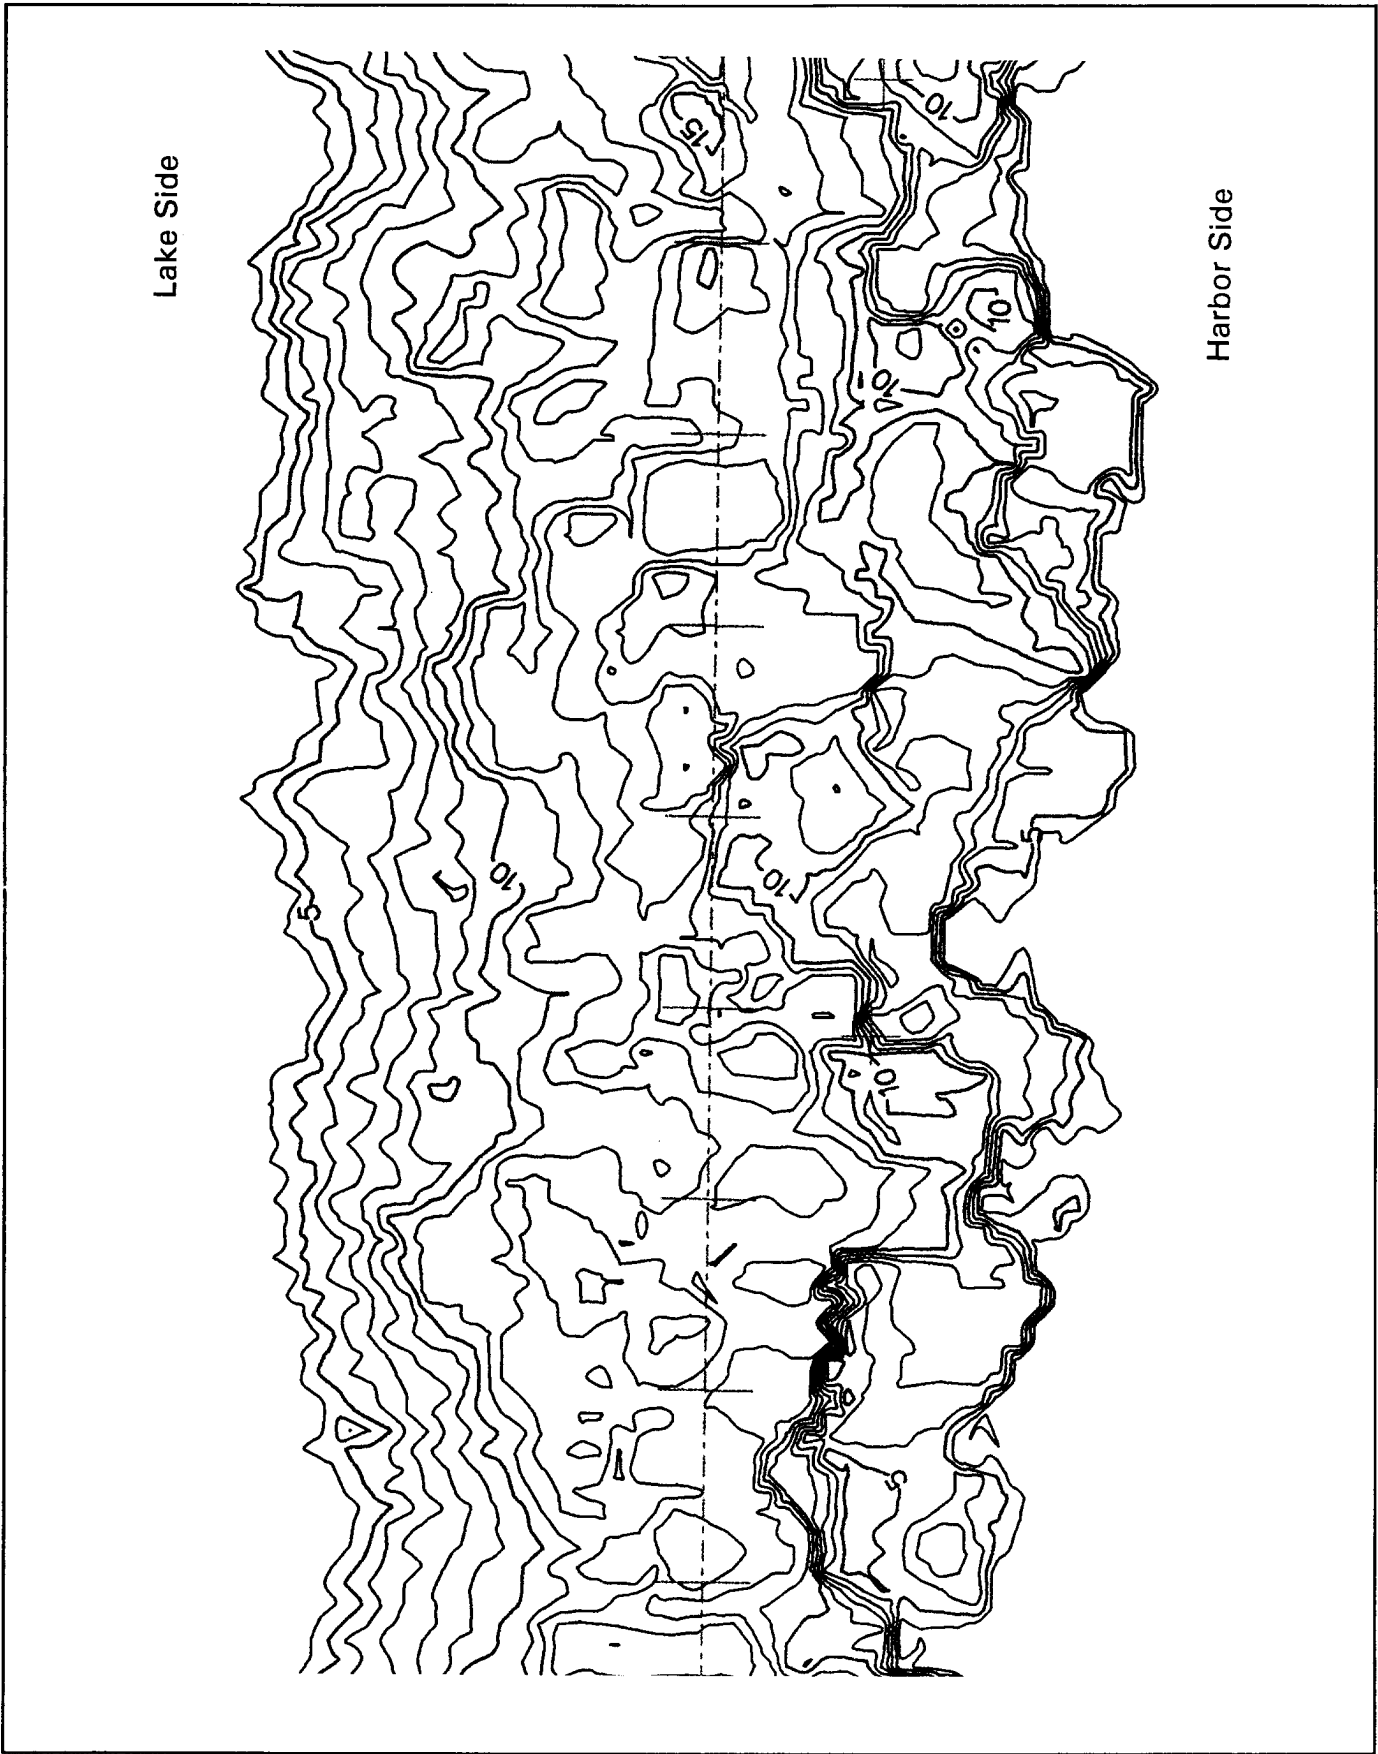
Figure A48. Topography of Burns Harbor North Breakwater, sta 40+10-40+95

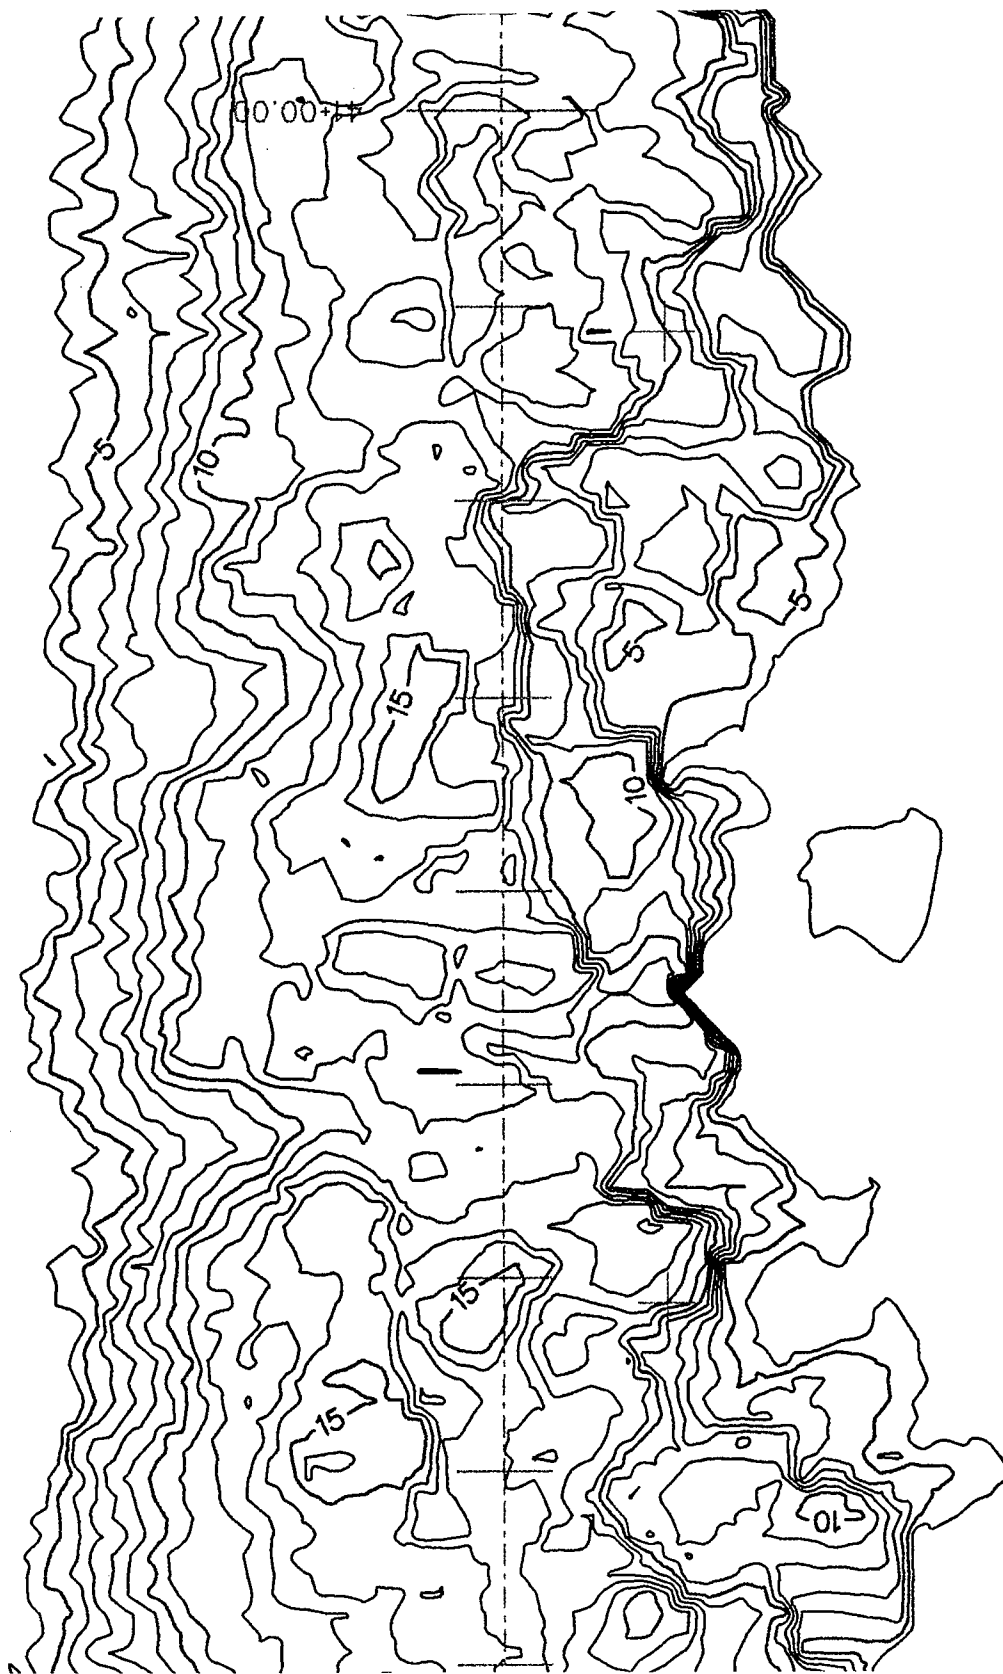
Figure A49. Topography of Burns Harbor North Breakwater, sta 40+95-41+80

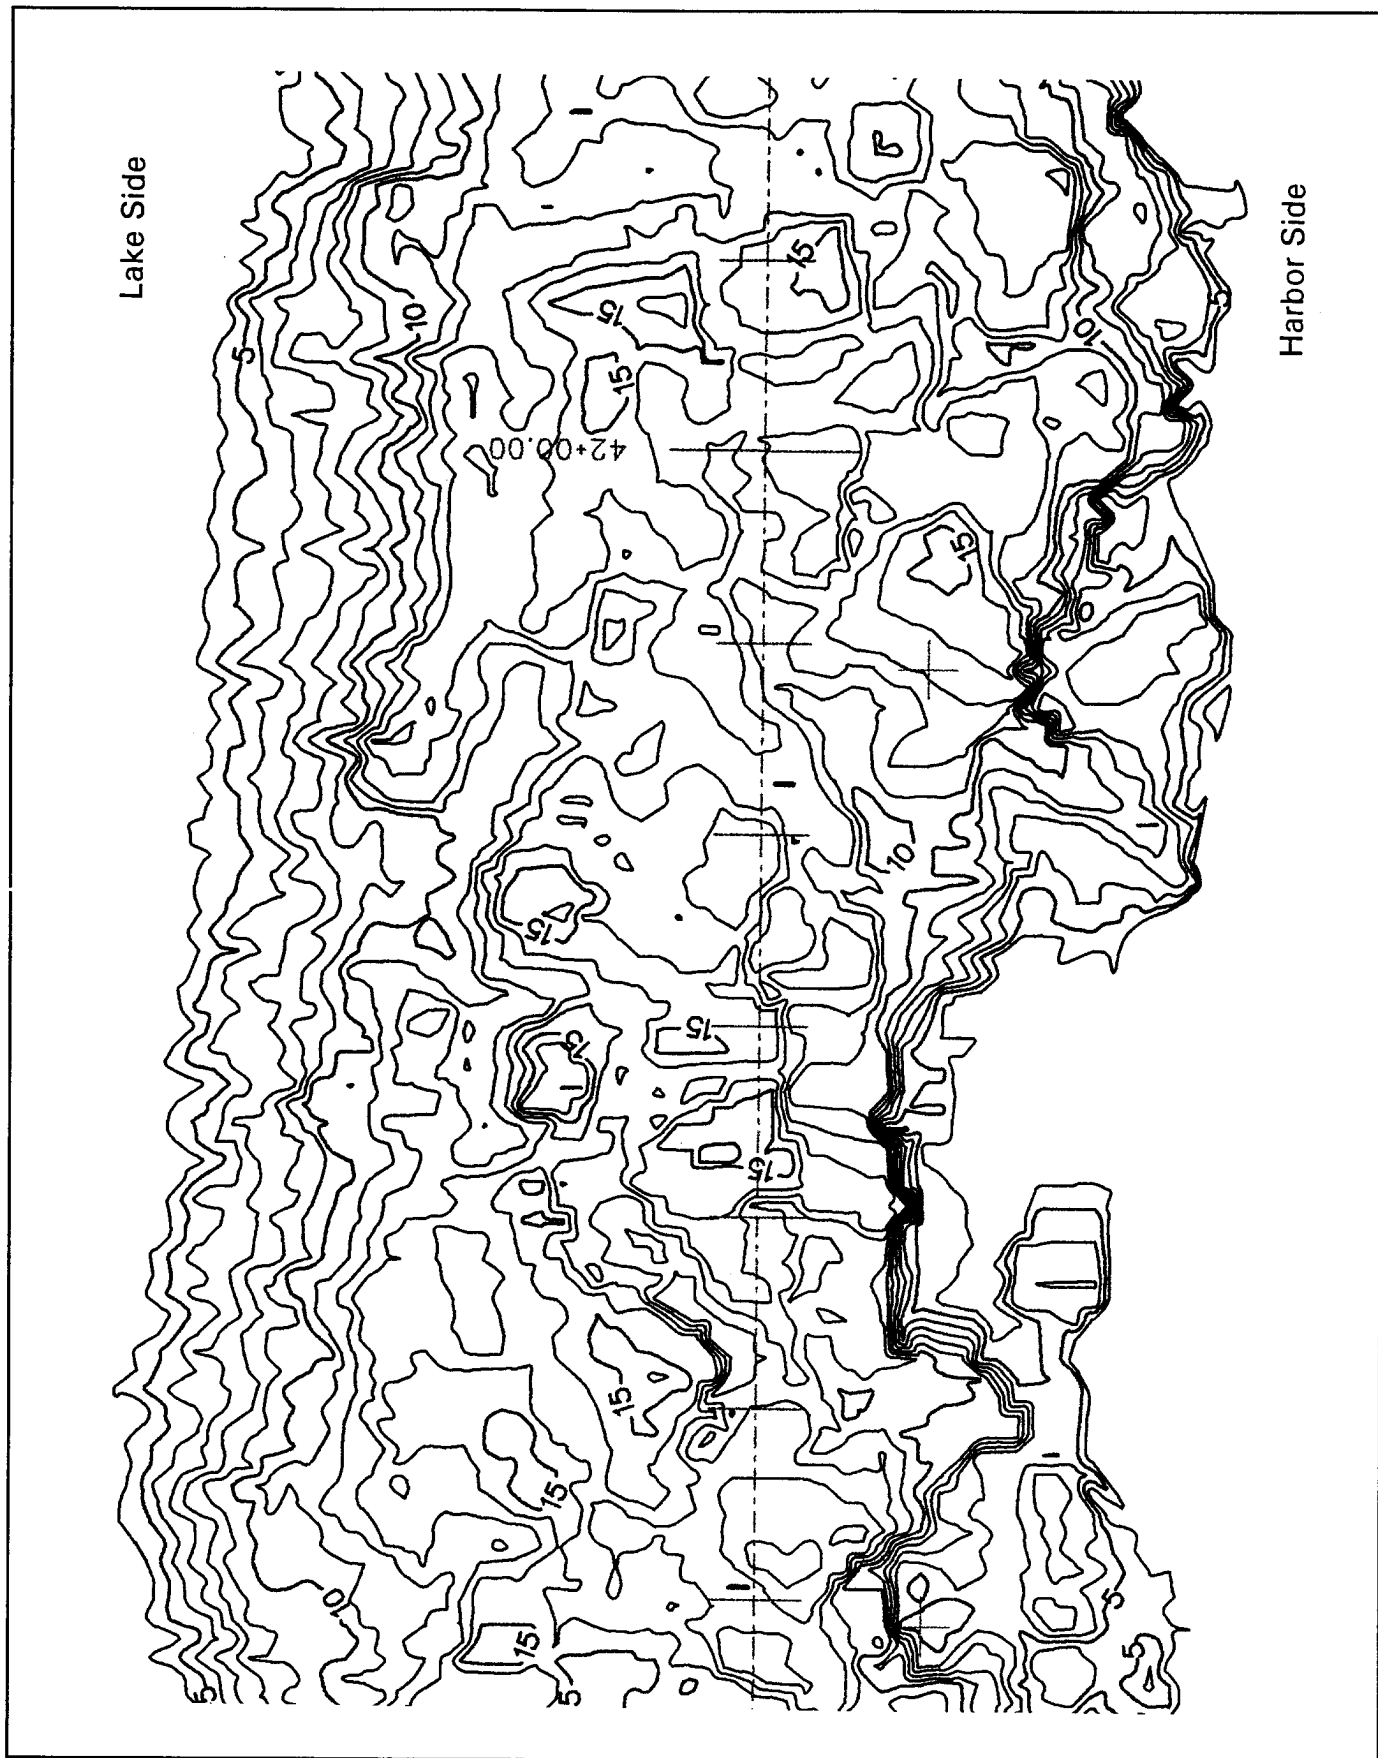
Figure A50. Topography of Burns Harbor North Breakwater, sta 41+80-42+66

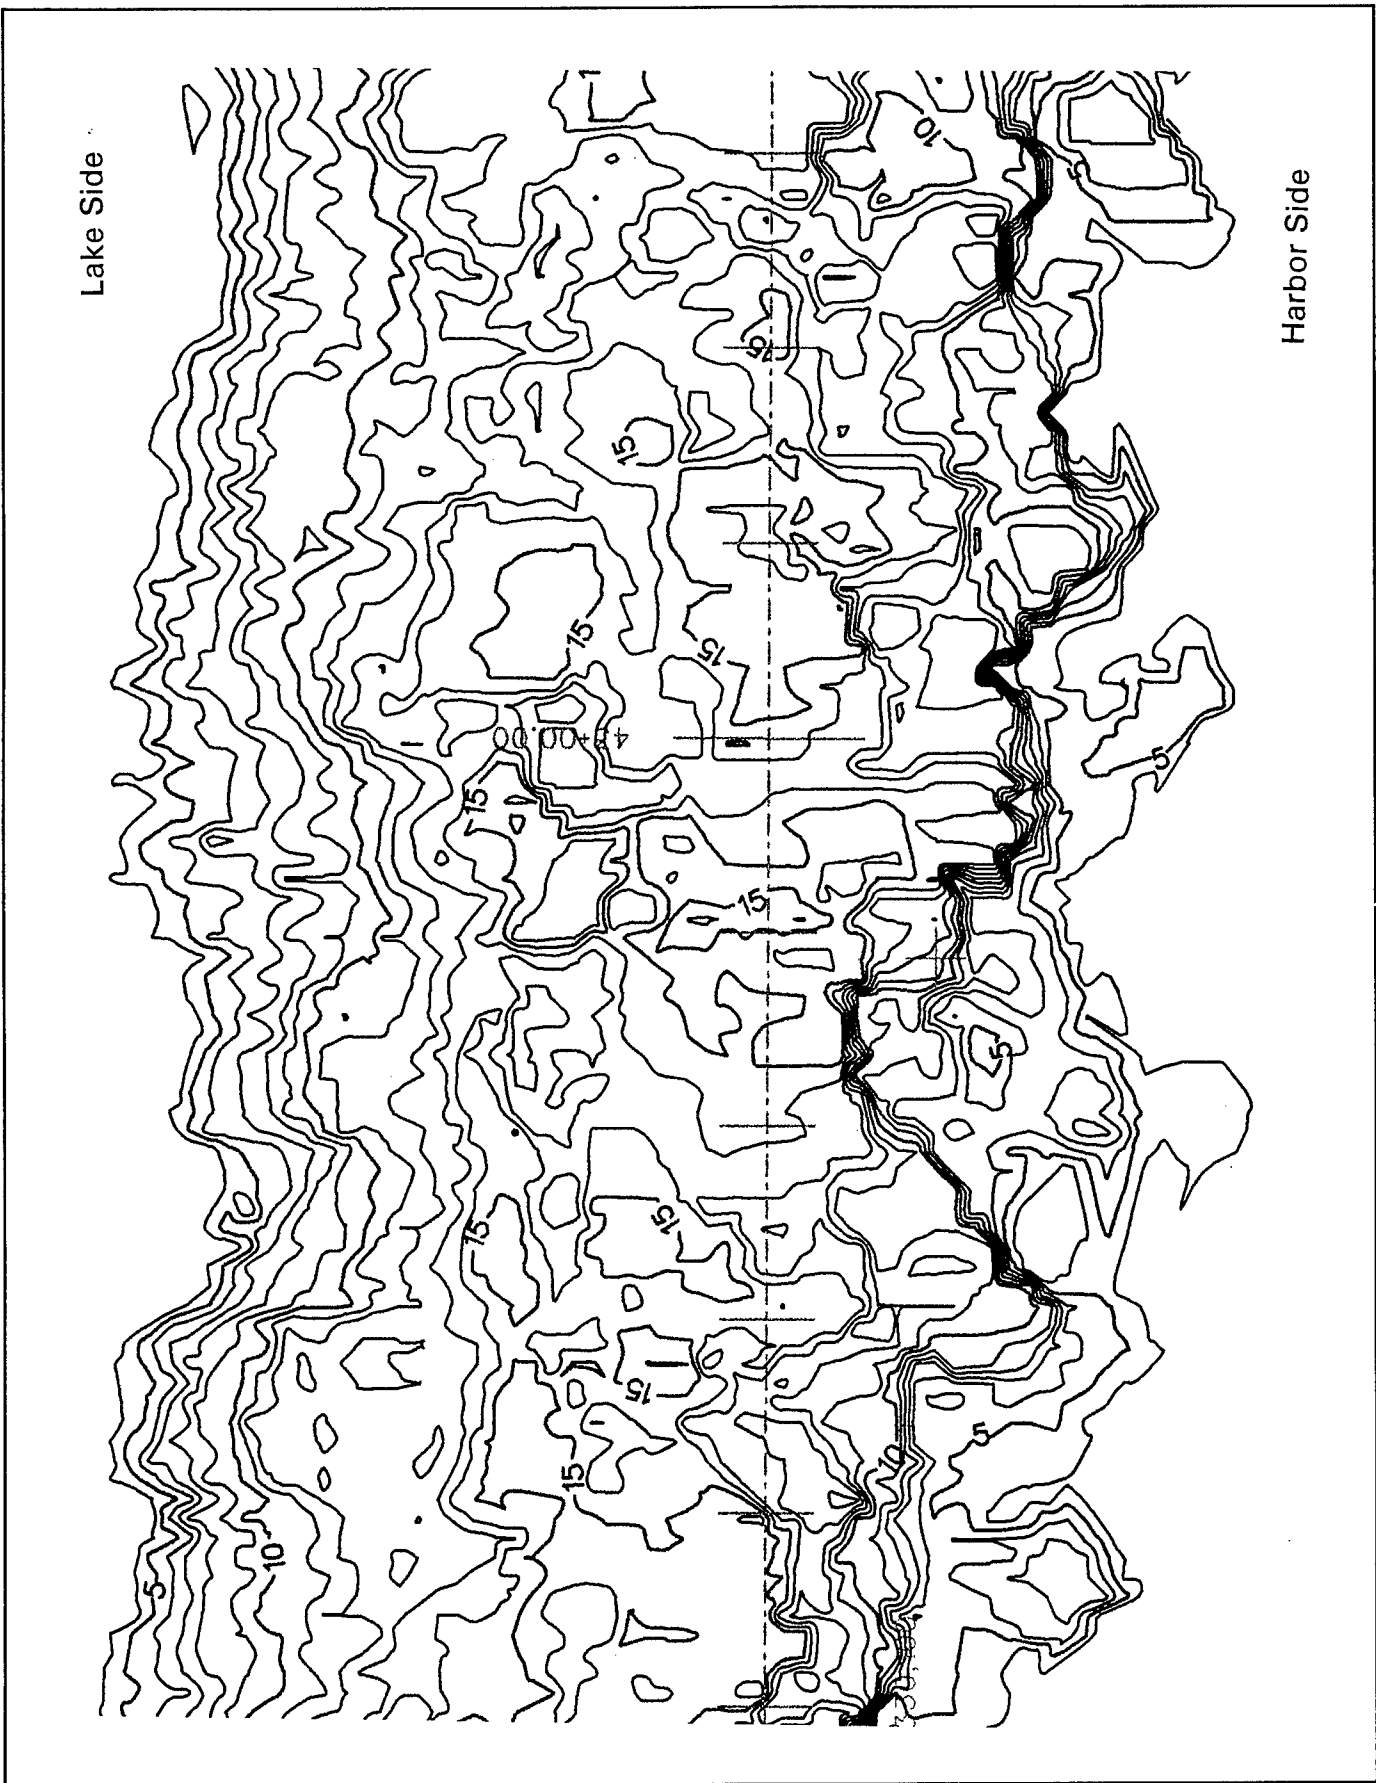
Figure A51. Topography of Burns Harbor North Breakwater, sta 42+66-43+51
